57th Canadian Geotechnical Conference 2004
Quebec City, Canada
"Geo-engineering for the society and its environment"

SLOPE HAZARD MANAGEMENT WITH THE CAUTIONARY ZONE APPROACH: A CASE HISTORY

Kerrie Fabius, Lakehead University, Thunder Bay
Mike Fabius, DST Consulting Engineers Inc., Thunder Bay
Sai Vanapalli, University of Ottawa, Ottawa
Gord Maki, DST Consulting Engineers Inc., Thunder Bay

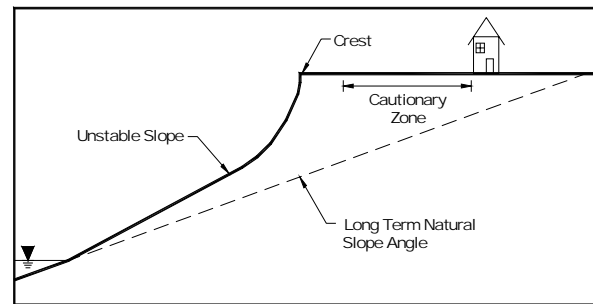
Figure 1. Illustration of the cautionary zone.

A Cautionary Zone Approach (CZA) was subsequently developed whereby the slope was allowed to regress, and stabilization measures were applied only when and where the crest of the slope reached the cautionary zone. Cautionary zone widths varying with respect to the degree of acceptable risk were established: 6 m for existing streets and 10 m for residences (Figure 1).

In summary, a cautionary zone consists of a strip of land along a property to be protected. Remedial action is required when the crest encroaches on the cautionary zone (Figure 1). The width of the cautionary zone can be varied with the desired degree of risk to be applied. At this site, the cautionary zone is 6 m for the street and 10 m for a house. These values are based on experience and on long term observations that slope failures at the

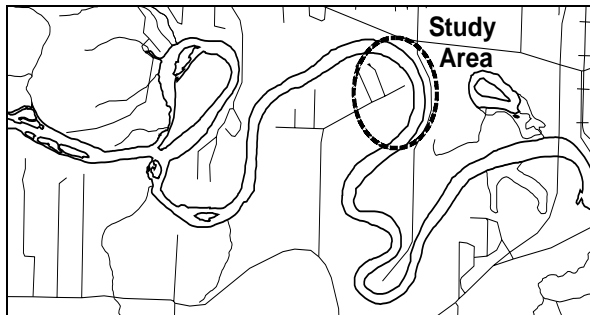
Figure 2. The Kaministiquia River.

The Kaministiquia River meanders through deep glacio-fluvial and glacio-lacustrine deposits on the way to its delta on Lake Superior in Canada. The study area comprises a 2 km stretch of steep 30 m high riverbank section in Thunder Bay (Figure 2). The slope is partially covered with mature trees. Where past failures have occurred, gullies have formed, devoid of vegetation. Perched groundwater in some areas seeps from sand layers near the top of the slope. Slope angles vary from 27° to 45° to the horizontal, the steeper sections being generally between gullies or at the scarps of gullies. Slope failures observed in the past have always been shallow, and occur after rainfall or during spring thawing.

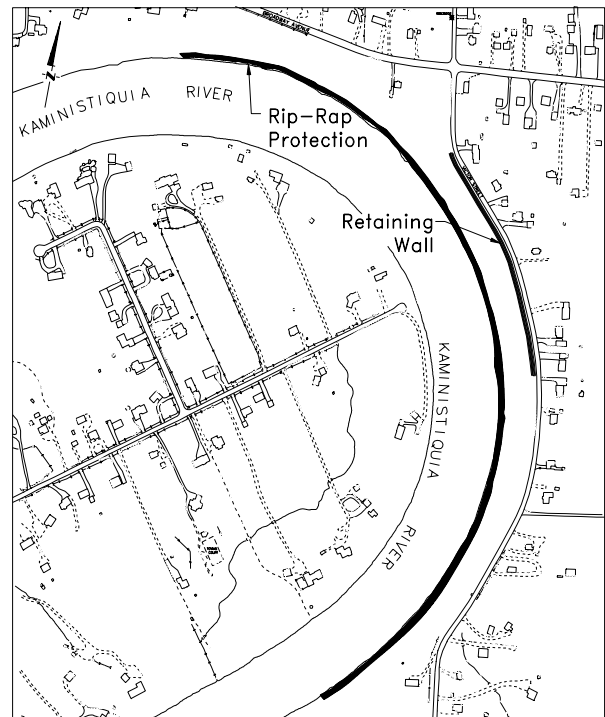
Figure 3. The study area.

A 1,200 m length of rockfill protection was placed along the toe to arrest further river erosion (Figure 3). It was predicted that the slope would naturally and gradually flatten to 24°, based on conventional slope stability analyses as well as observations of a nearby slope at an oxbow lake cut off from the river. This meant that eventually the street and several houses would be lost. Six houses that were within 10 m of the crest were purchased and demolished by the LRCA. Furthermore, a 350 m length of street where the crest encroached within 6 m (a cautionary zone) was stabilized with a retaining wall along the top of the slope (Figure 3) as described by Fabius and Suke, 1990.

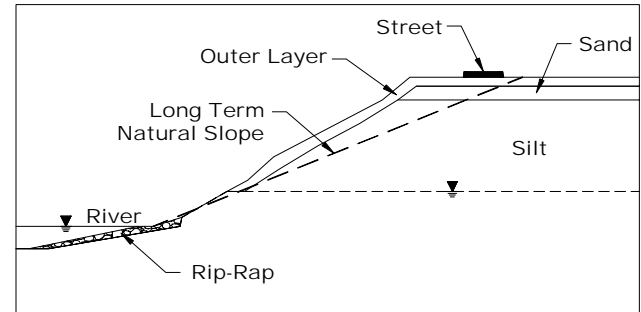
Figure 4. 2003 Kaministiquia River slope model.

A model of the Kaministiquia River bank in 2003 was selected based on stratigraphy from several boreholes and logging various surface sections (Figure 4). The section includes a 2 m thick surface layer over the slope to represent soil susceptible to desaturation from

Cases 2 to 7 model the 2003 unsaturated slope shown in Figure 4. From Case 2 to Case 5, the factor of safety increases with soil suction. The failure mode at the minimum factor of safety is deep, which does not model the observed slope failures.

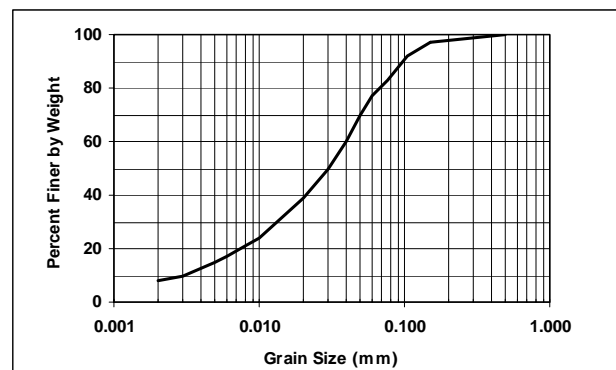
Figure 5. Grainsize curve of Kaministiquia River silt.

The soil-water characteristic curves for sand and silt layers were estimated by SoilVision software based on grain size (Figure 5), specific gravity and void ratio data. The SWCC for the predominant silt layer is shown in Figure 6. The soil matric suction (negative pore-water pressure) for the sand was estimated to vary between 1 and 100 kPa, and 5 and 500 kPa for the silt layer.

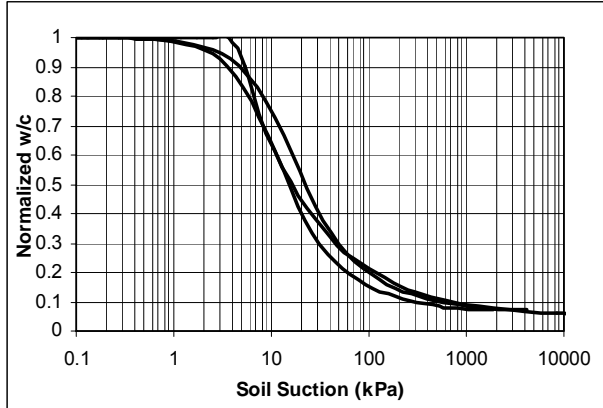
Figure 6. Estimated SWCC for Kaministiquia River silt.

Case 7 with no suction in the outer 2m thick layer appears to most reasonably match the observation of shallow failures. The ground water table of 189 m elevation and friction angle due to suction, $\phi^b = 15^\circ$ will be used to analyze the CZA. Since there are no recorded deep failures, and there are no signs of deep soil movements such as cracks in the street at the crest, the safety factor against deep failures (through unsaturated soil below the outer layer) must be at least 1.1 if not higher. To ensure a factor of safety of 1.1 the soil suction must be at least 100 kPa (Table 1, Case 4). However, the matric suction could be up to 500 kPa (from the soil water characteristic curve for silt, Figure 6)

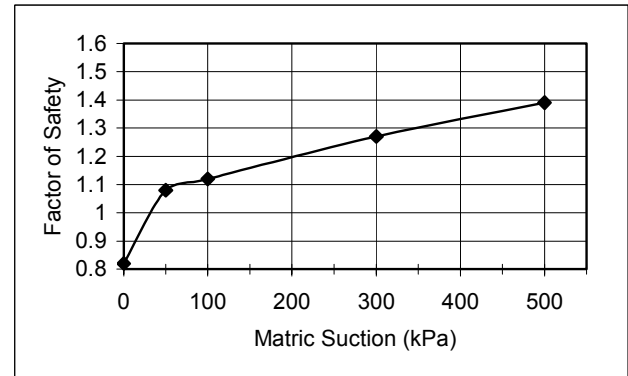
Figure 7. Variation in stability with matric suction in the outer layer.

Matric suction was the first variable considered in the analysis. Results are summarized in Table 1 for seven different matric suction values using the minimum ϕ^b value, which is equal to 15° . Figure 7 illustrates the analysis results. For each case it was observed whether the critical slip surface was deep or shallow.

Cases 6 and 7 simulate the outer 2 m layer of soil becoming saturated from rain, losing much of its strength contribution due to matric suction. Case 6 has 5 kPa of suction remaining in the outer layer, and 100 kPa in the layer below. The result is a deep seated failure illustrating that even a very small suction will hold a slope against shallow instability. With the matric suction at zero in the outer soil layer (Case 7), a shallow failure occurs within the outer layer.

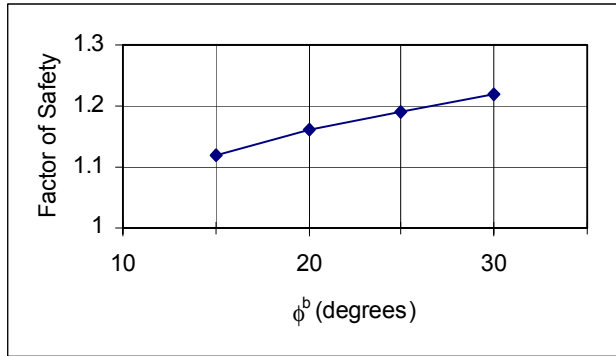
Figure 8. Effect of ϕ^b on stability.

The parameter ϕ^b was modelled from a conservative value of 15° up to 30° in 5° increments. Figure 8 shows the variation of factor of safety with respect to the friction angle ϕ^b . The factor of safety increases as ϕ^b increases. However, the change in factor of safety is not significant showing that changing ϕ^b does not affect this particular slope significantly. However, to be conservative, $\phi^b=15^\circ$ was selected to model the actual case.

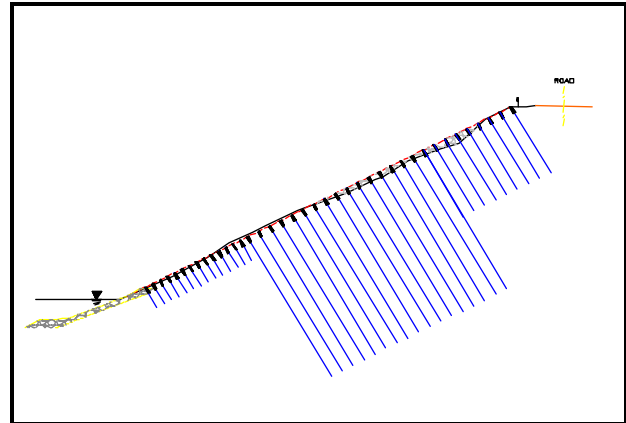
Figure 9. Typical soil nail design layout.

The limiting factor for economical soil nails is the ability to install the nails to sufficient depths without drilling. Based on numerical analyses, soil nails driven to a depth of 21 m along the upper half of the slope increase the factor of safety to about 1.3, equivalent to that of the soldier pile retaining wall already in place. Subsequent field trials confirmed that soil nails could be economically installed on the slope to the required depth without adverse impacts to the existing vegetation. A typical design layout for nails is illustrated on Figure 9.
